Performance Evaluation of One-Coat Systems for New Steel Bridges

PUBLICATION NO. FHWA-HRT-11-046

JUNE 2011

U.S. Department of Transportation
Federal Highway Administration

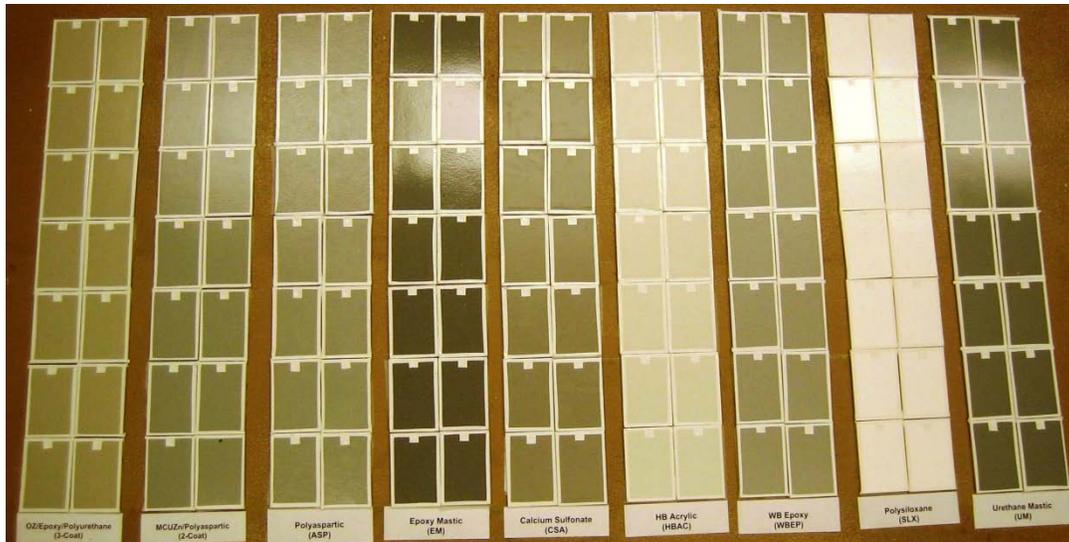
Figure 1. Photo. Composite of small panels.

Two sizes of steel test panels were used in this study. The small panels were 4 x 6 x 0.2 inches (10 x 15 x 0.48 cm), while the large panels were 6 x 12 x 0.2 inches (15 x 30 x 0.48 cm) (see figure 1 and figure 2). All test panels were blast cleaned to Society for Protective Coatings (SSPC) specification (SP)-10 with measured anchor profiles in the range of 2.2–2.9 mil (55–72 μm).⁽¹⁵⁾ Coatings were then applied on the cleaned test panels using an airless spray method by a professional coating laboratory.

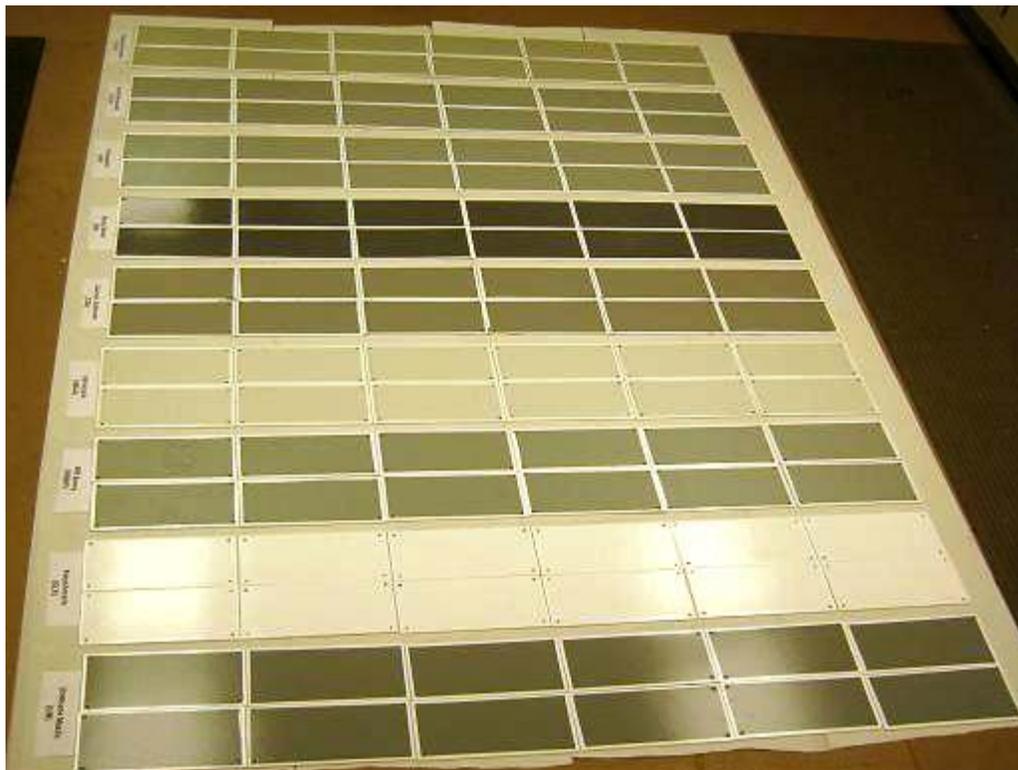
Figure 2. Photo. Composite of large panels.

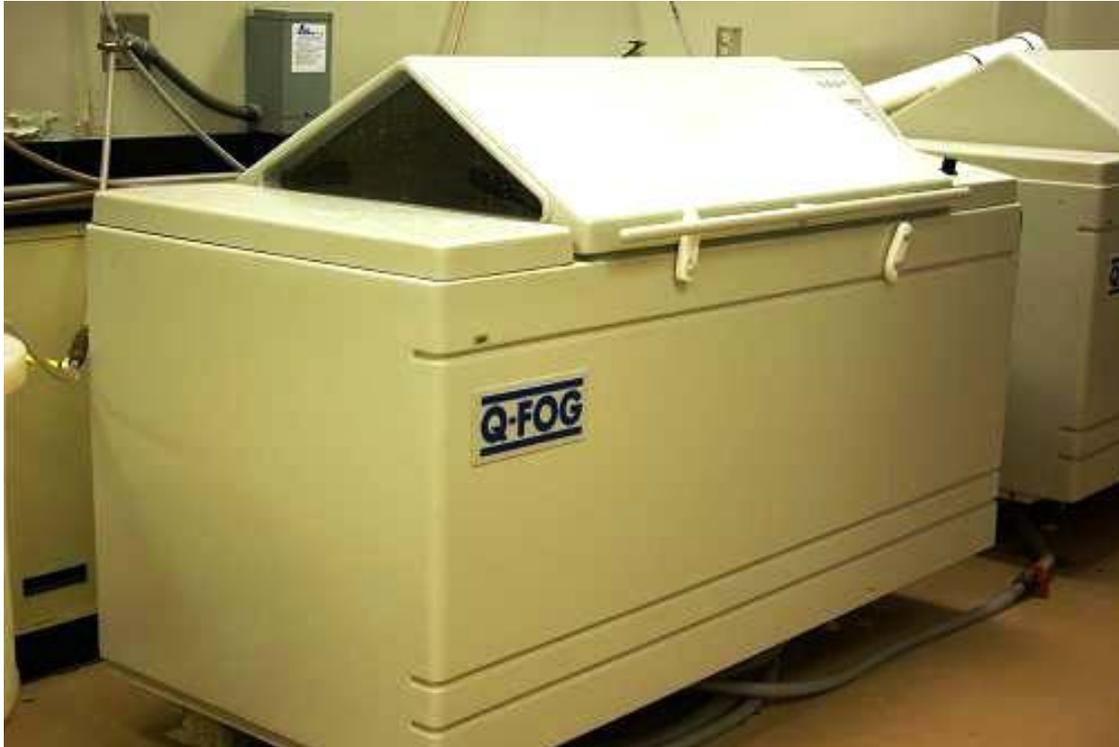
Figure 4. Photo. Salt-fog chamber.

Figure 4 and figure 5 show a salt fog chamber and a weathering tester, respectively. A 16-h salt-fog accumulation test was conducted before each cyclic salt-fog test to check the atomizing and fog quantity as well as the pH of the collected solution. The test panels were evaluated after every test cycle of 360 h and at the termination of each laboratory test.

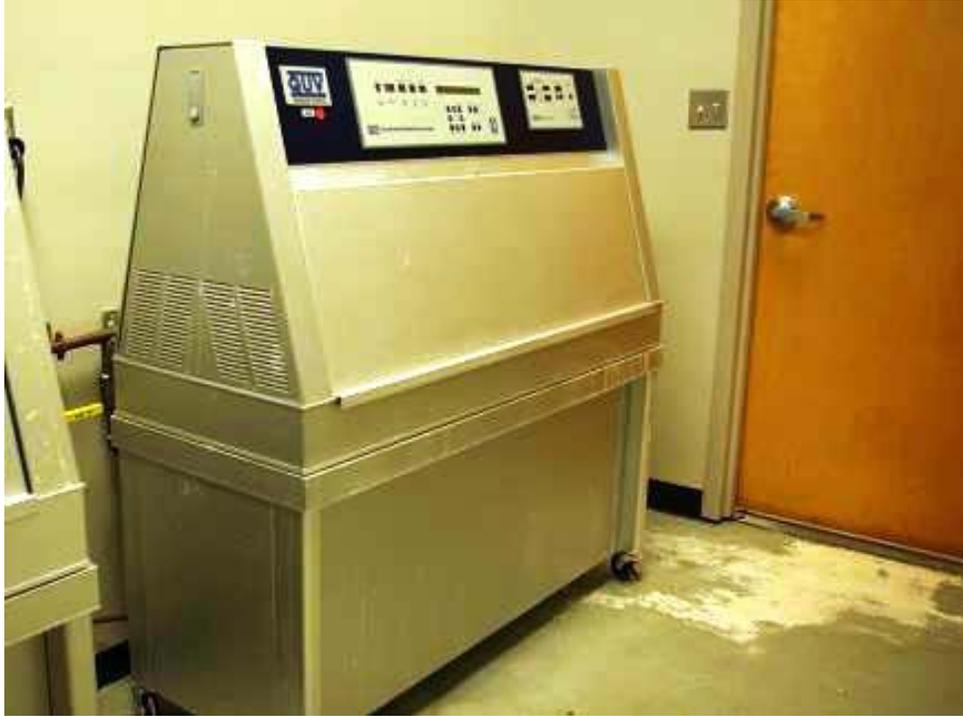
Figure 5. Photo. UV weathering tester.

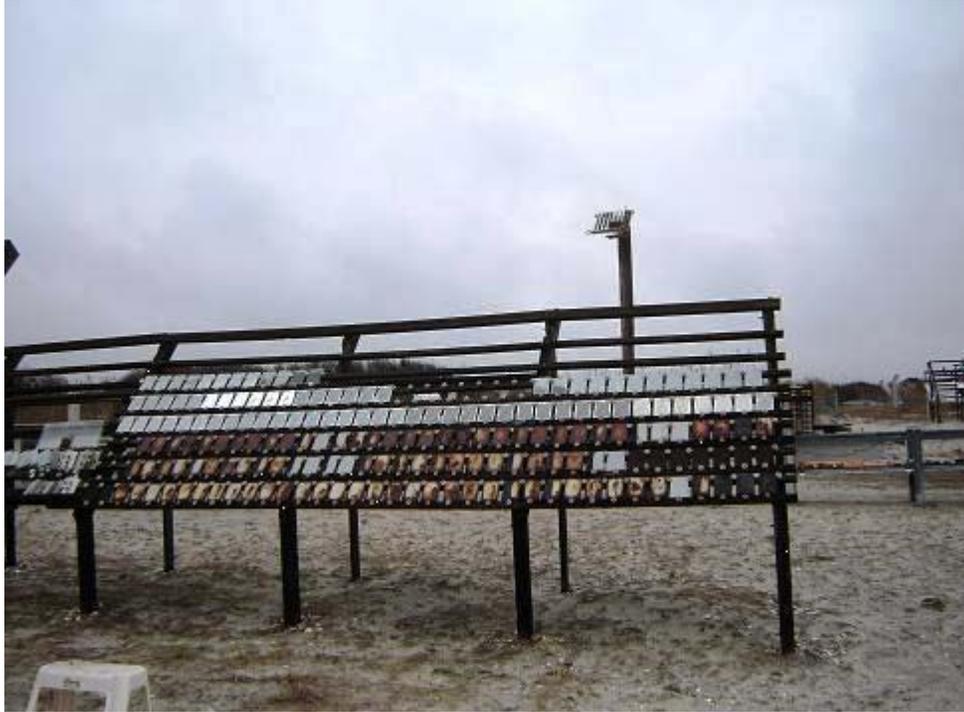
Figure 6. Photo. ME exposure rack in Sea Isle City, NJ.

A group of 54 test panels was exposed in Sea Isle City, NJ, at a ME site. All of the test panels were placed on a 45-degree-angle wooden rack facing south as shown in figure 6. The test site is located in a harsh environment with high chloride and high time-of-wetness.⁽¹⁸⁾ Table 3 lists the summary of the environmental factors during the 2-year panel exposure period. The test panels were sent back to TFHRC CCL for performance evaluation every 6 months. The total exposure time was 24 months.

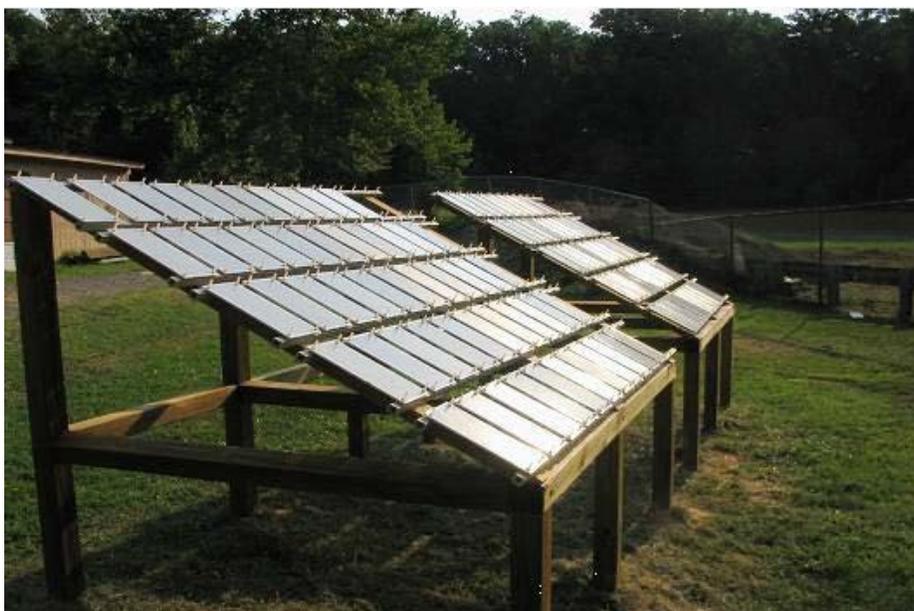
Figure 7. Photo. Mild NW exposure rack at TFHRC.

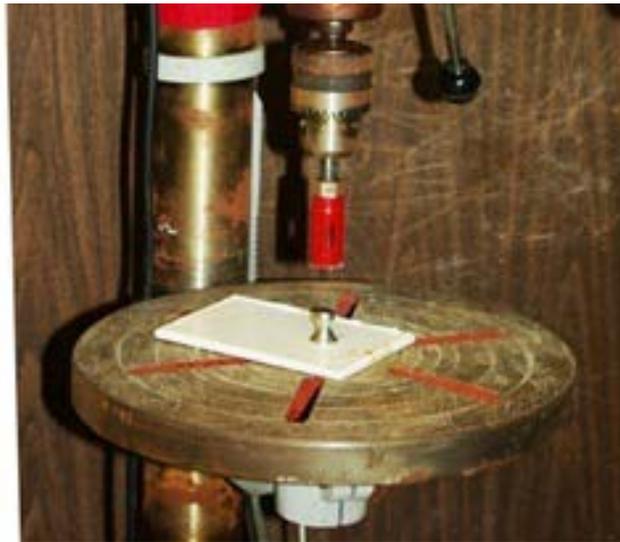
Figure 9. Photo. Drill press to score a test area around a dolly.

The surface of coated test panels and the base of the dollies were cleaned with detergent water and were lightly roughened with an abrasive pad. The dollies were glued to the test panel surface using a high-strength epoxy adhesive. The cut through the coating around the edge of the dolly was performed using a drill press after the complete cure of the adhesive shown in figure 9. The initial adhesion strength was measured by two pull-off methods: the hydraulic method and the pneumatic method. The final adhesion strengths of coating systems were measured using the hydraulic method. Figure 10 shows the hydraulic adhesion tester used to pull off the dollies for adhesion strength testing. Three pull-off adhesion tests were performed after exposure on each test panel except for some UM and ASP test panels due to their severe surface failures after ALT. No adhesion tests were performed on scribed UM and ASP test panels, while two adhesion tests were performed on unscribed UM panels.

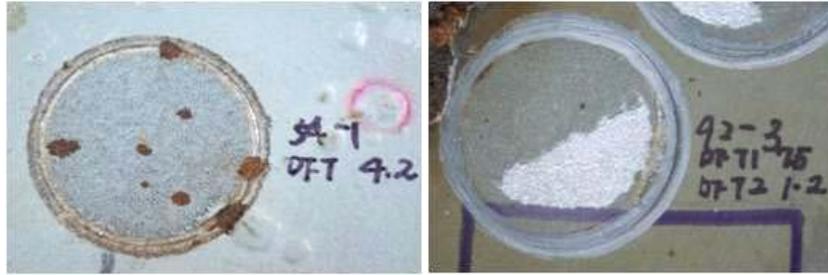
Figure 18. Photo. Cohesive failure modes of ASP and EM.

The three-coat system, EM, and WBEP had a shallow cohesive failure mode where residual DFT were close to their initial DFT, and the failure mode was observed close to the panel surface. Figure 18 shows the cohesive failure mode of the ASP and EM test panels. ASP had an initial DFT of 20 mil (508µm), leaving 4 mil (101.6µm) of DFT on the adhesion spot after testing. EM coating system had an initial DFT of 9 mil (228.6µm) and had 8 mil (203.2µm) of DFT remaining on the pull-off spot after the test.

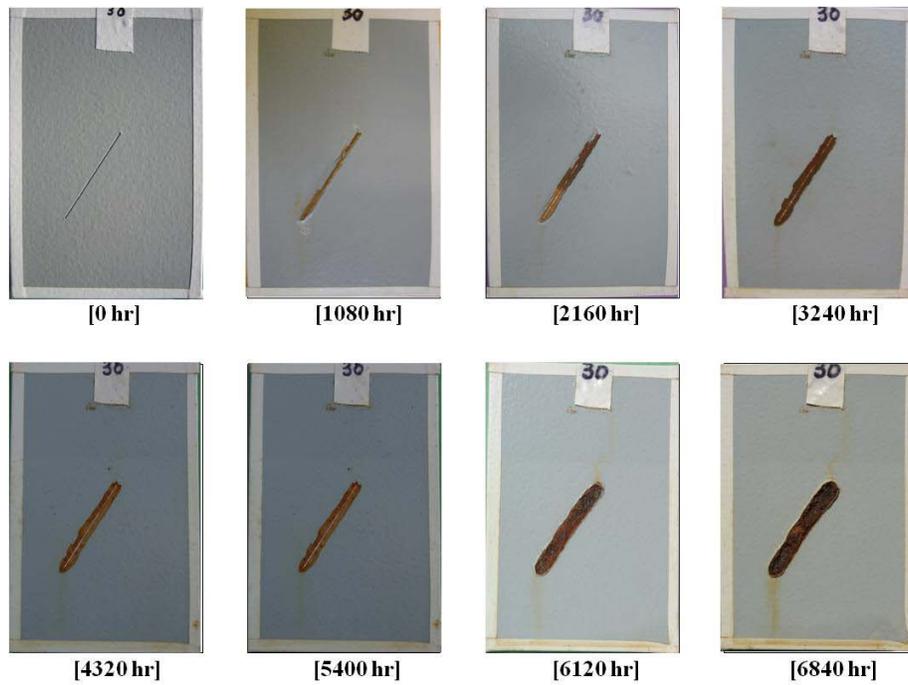
Figure 23. Photo. Progressive changes of panel 30 (two-coat: ALT).

The two-coat (see figure 23) and EM (see figure 31) coating systems reacted differently compared to ASP and UM. Both systems did not develop any surface blisters or rust pits during the entire test period. However, when panels from the two-coat system were scanned by the holiday detector after 6,120 h, all of the test panels suggested the development of numerous defects by emitting a countless beeping sound. Most of the EM panels also indicated many defects after 6,480 h. Microscopic examination revealed numerous hairline cracks that had developed on the surface of the two-coat test panels. Figure 60 shows the photomicrograph of surface cracking of the two-coat panels. EM, however, did not show any surface cracking/deterioration when examined under the optical microscope.

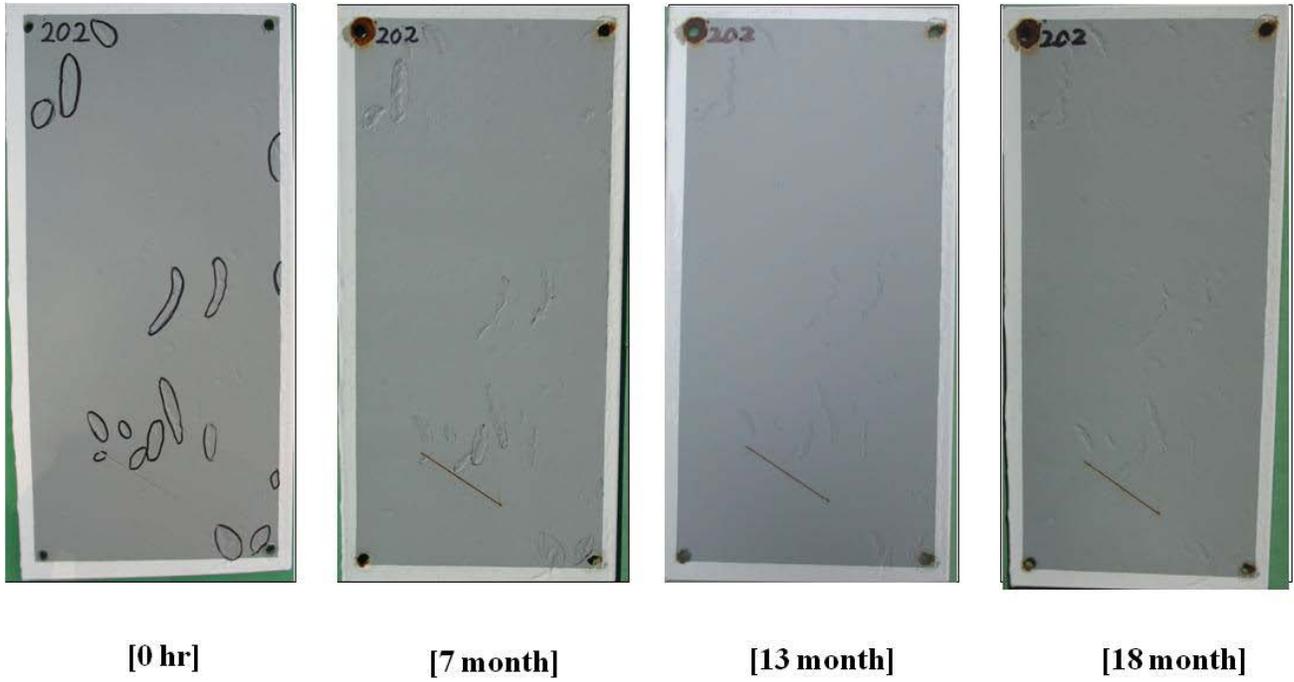
Figure 46. Photo. Progressive changes of panel 202 (WBEP: NW).

All coating systems performed well in NW and NWS except for WBEP (see figure 46 and figure 47). As discussed earlier, WBEP test panels had some initial film defects. DFT was less than 1 mil ($25.4\mu\text{m}$) at several areas. There were also some small dent areas on the surface. Typical defective surface condition and the resultant surface appearance after outdoor exposure can be seen in figure 62. The small dents grew into size 6 blisters after NW. In NWS, the small dents grew into size 6 rusted blisters, and all of the thin DFT areas became rusted (the rusting grade was G6). Many defects were detected by the holiday detector on the test panel surfaces.

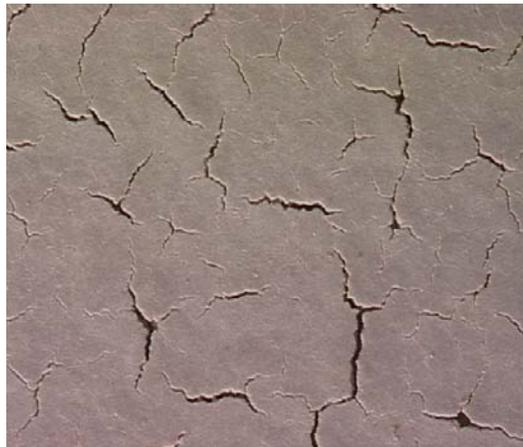
Figure 60. Photo. Surface coating failure by cracking (two-coat system).

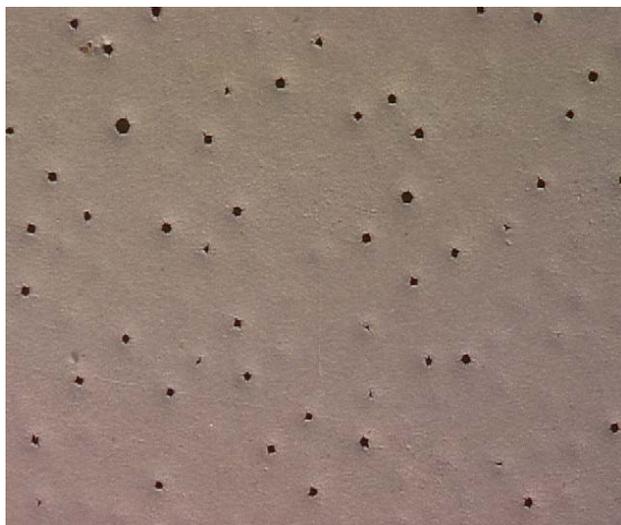
Figure 61. Photo. Surface condition of the three-coat system.

The microscopic examination of the three-coat system taken after 6,120 h also revealed some small holes on the panel surfaces. Figure 61 shows the photomicrographs of the surface of the three-coat system. However, the micro-sized holes were not holidays and thus did not affect the coating performance during ALT.
