# HRCSA NEWS

## HRCSA Global Newsletter

### HRCSA Challenge

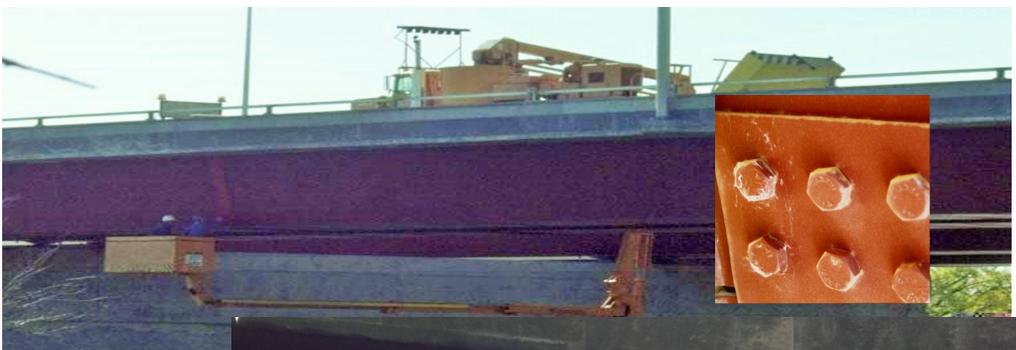
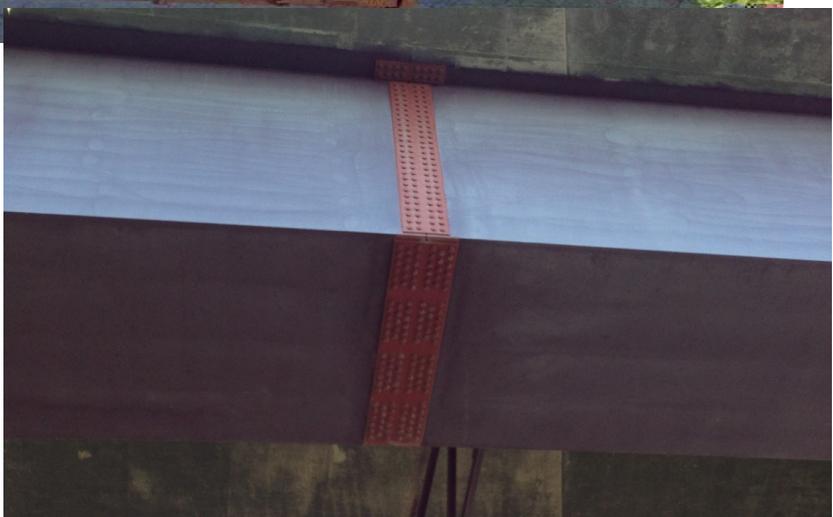
**The bridge shown below had been coated with 3 coat zinc-epoxy-urethane (ZEU).**

One year after the initial 1991 application, inspectors noticed ZEU failing in one year at all connections along edges of steel plate and bolt heads.

*“The HRCSA coating did not undercut or bleed rust at the connection for over 26 years. The ZEU system has begun fading and chalking and the performance difference between the two is obvious.*

Because coating was new, the connection was pressure washed with salt remover additive, dried and overcoated with color matched HRCSA. (top photo).
